## MEMORANDUM

**Project:** 090557-01

**Re:** Post TCRA Quarterly Inspection Report - January 2012 Inspection

This document reports the results of the quarterly inspection conducted in January 2012 for the San Jacinto River Waste Pits (SJRWP) Time Critical Removal Action (TCRA) as required by the schedule established in the Operations, Monitoring, and Maintenance (OMM) Plan (Appendix N – Anchor QEA 2011b). The OMM Plan specifies the timing, pertinent items, tolerances, and procedures for inspection and repair of the protective cover, fencing, and signage installed for the TCRA at the San Jacinto River Waste Pits Superfund Site (Site) in Harris County, Texas (Figure 1).

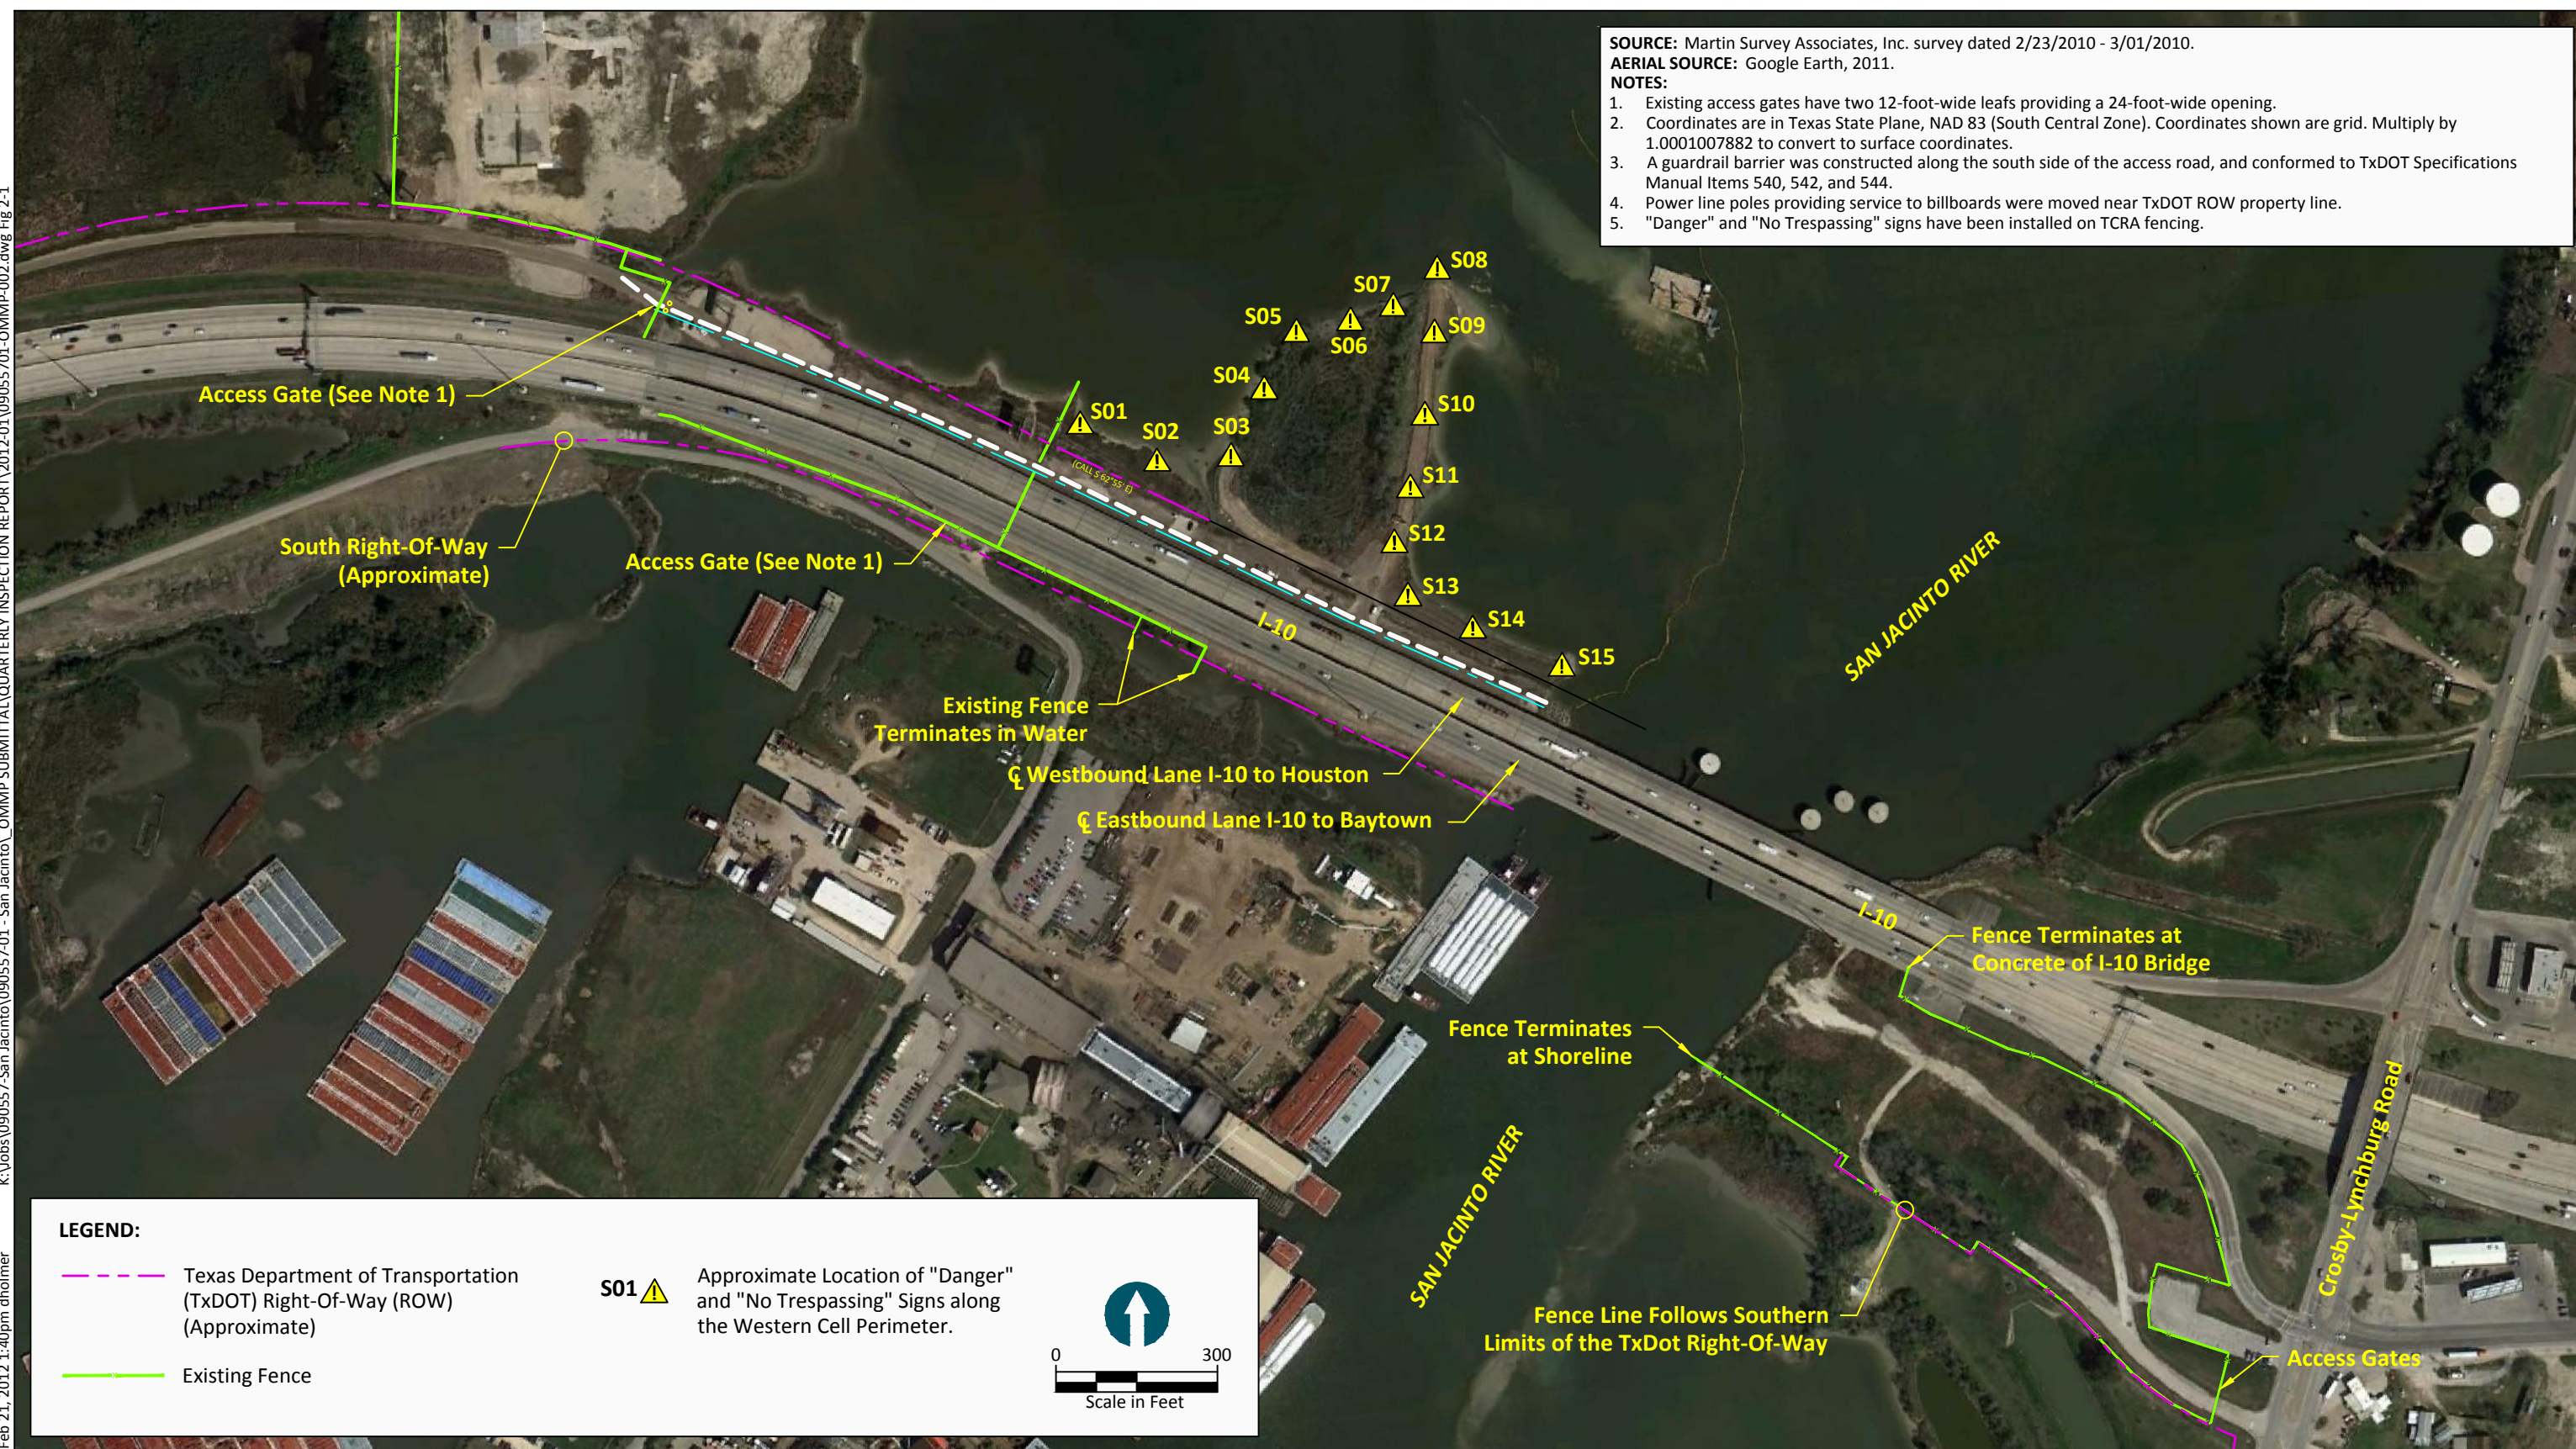
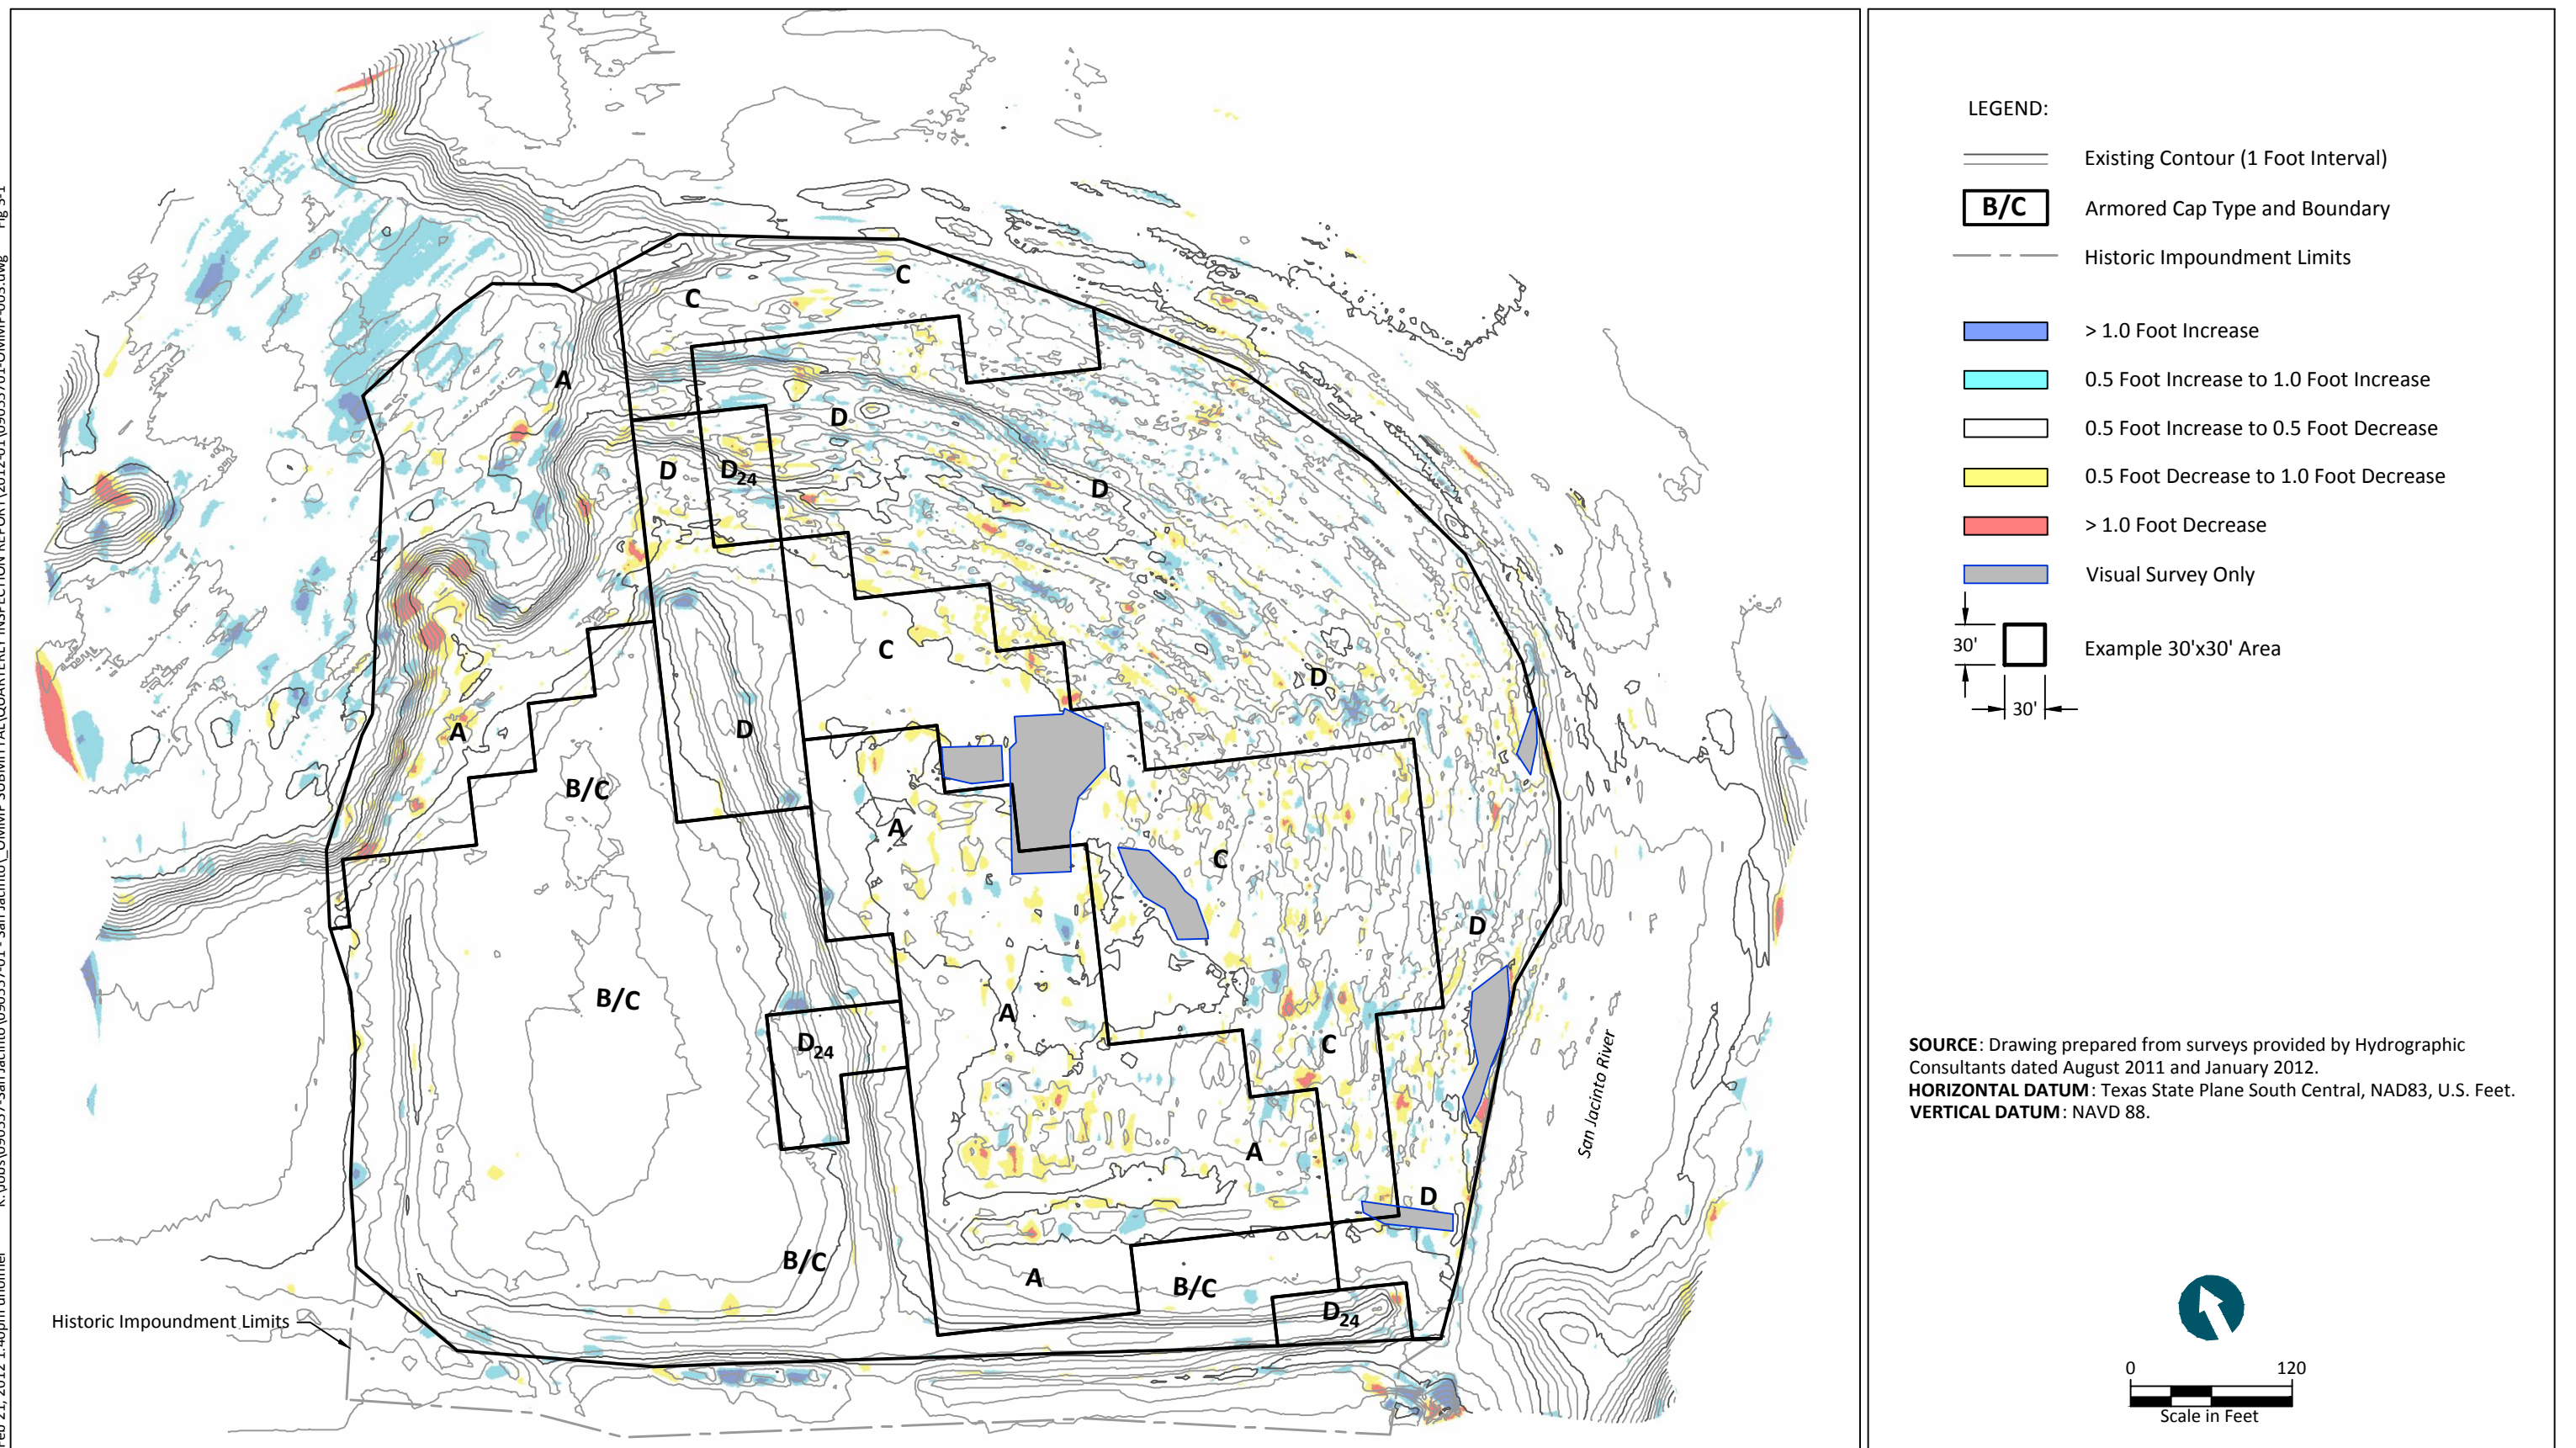
K:\Jobs\090557-San Jacinto\090557-01 - San Jacinto\OMMP SUBMITTAL\QUARTERLY INSPECTION REPORT\2012-01\09055701-OMMP-002.dwg Fig 2-1  
Feb 21, 2012 1:40pm dholmer

The survey for this quarterly inspection event was conducted by Hydrographic Consultants, Ltd. on January 27, 2012 until January 31, 2012. Figure 3 displays the completed survey. As previously discussed, limited portions of the survey area could not be accessed due to low tides and unsafe shallow-water walking conditions and are indicated by a distinct hatching on Figure 3.

This survey dataset was compared to the baseline survey<sup>1</sup> to evaluate the differences in the top of armor cap elevation between surveys. These differences are provided in the differences plot on Figure 3.

The threshold limits established by the OMM Plan ( $\pm 0.5$  foot over a 30 foot by 30 foot area) were not exceeded and probing was not required.

With regard to the armored cap survey, the small areas identified as increases and decreases in elevation can be attributed to the horizontal and vertical accuracy of the survey, minor shifts in track line location from the baseline survey, elevation data recorded in the crevices between rock surfaces, or other related measuring inaccuracies. The potential for these inaccuracies to exist was confirmed by the surveyor after reviewing the data. The photographs taken in the eastern cell at these locations during low tides indicate that the armored cap is in place, as constructed.

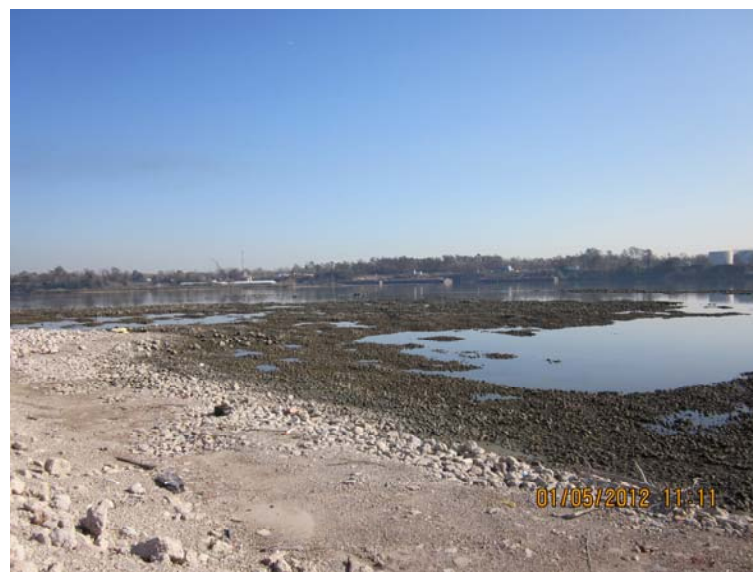
The upland portions of the armored cap were visually inspected on January 5, 2012. Photographs from the inspection event are provided in Appendix A (Photographs 01-14). None of the visible portions of the armored cap were identified as having been breached or otherwise damaged. Several of the photographs provide armored cap visual inspection for areas that could not be surveyed, as explained in Section 3 – Surveys. As shown in photographs taken along the eastern boundary of the Eastern Cell (Photographs 04, 08 thru 10, and 12 thru 14) no movement or erosion of waste materials into the River was observed.

Photo: 04 View of Eastern Cell; photo shows intact armored cap for areas unable to be surveyed (view northeast)

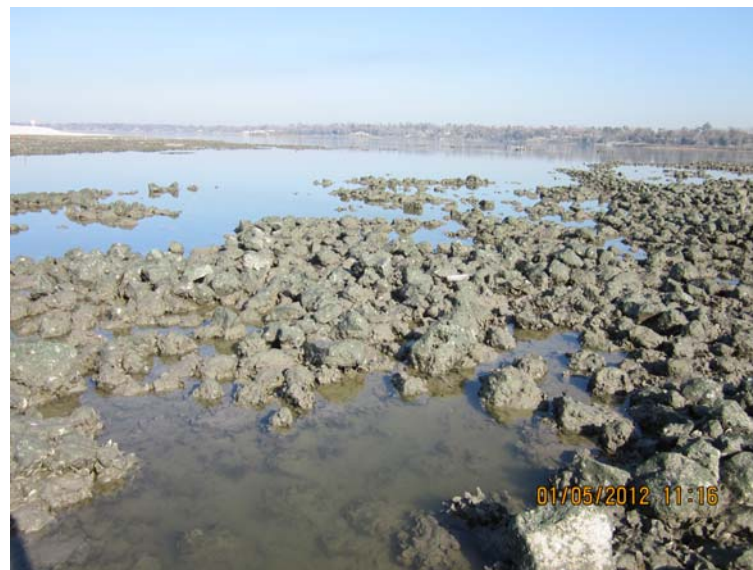
Photo: 08 View of Eastern Cell (central portion of upland rock) from the Southern Berm; photo shows intact armored cap for areas unable to be surveyed (view north)

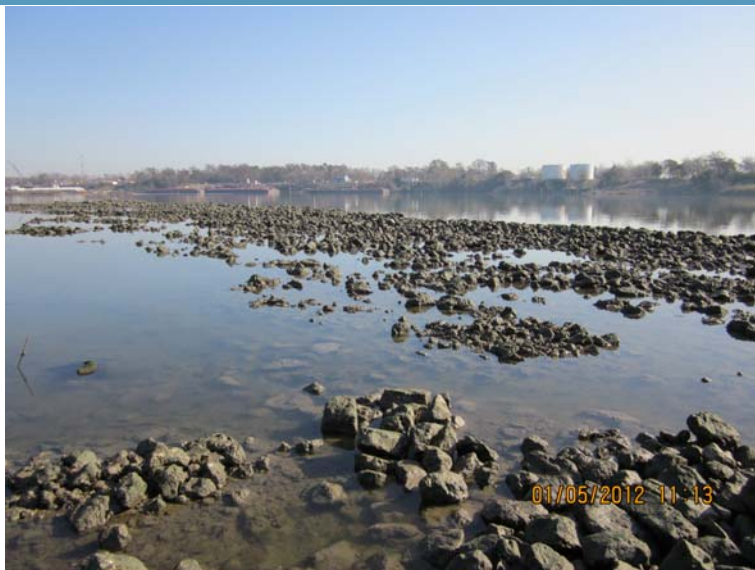
Photo: 09 View of Eastern Cell (eastern perimeter) from the Southern Berm; photo shows intact armored cap for areas unable to be surveyed (view northeast)

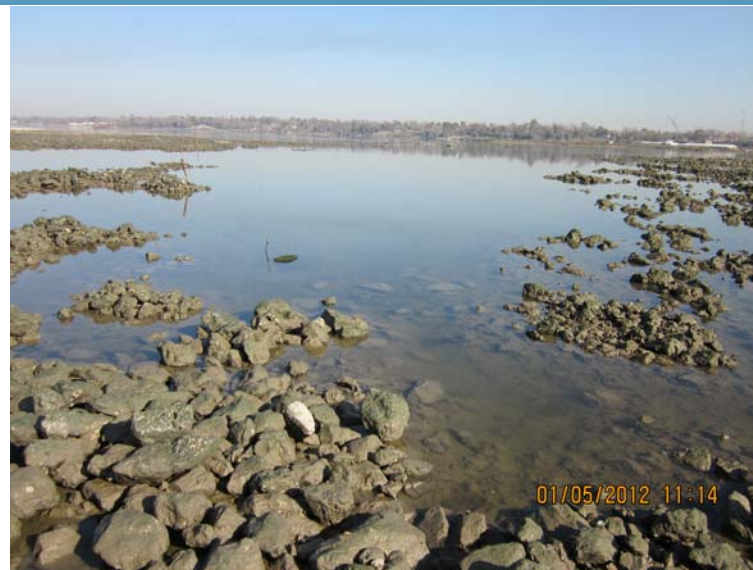
Photo: 10 View of Eastern Cell (central portion of upland rock) from the Southern Berm; photo shows intact armored cap for areas unable to be surveyed (view north)

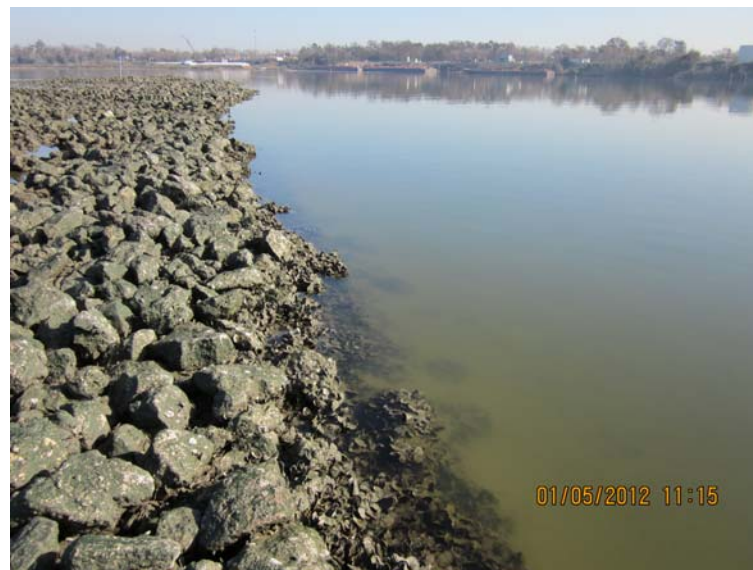
Photo: 12 View of thickened edge Eastern Cell adjacent to the San Jacinto River; photo shows intact armored cap for areas unable to be surveyed (view north)

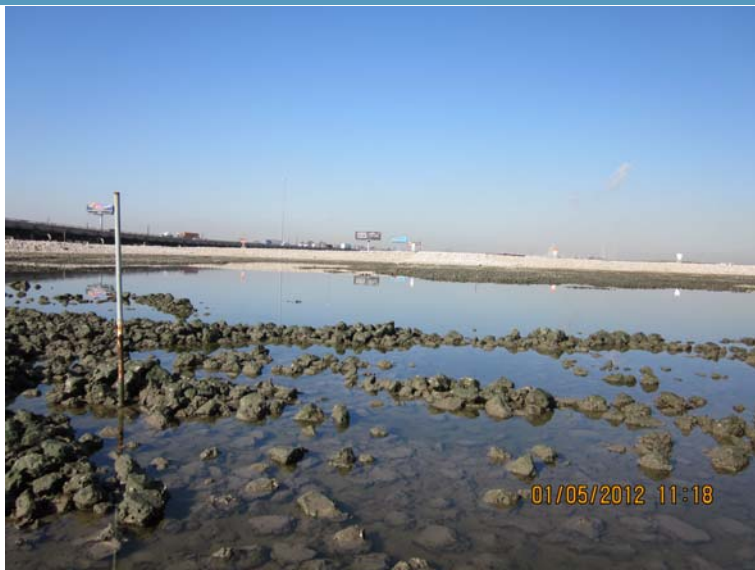
Photo: 13 View of Eastern Cell from the thickened edge along the eastern boundary; photo shows intact armored cap for areas unable to be surveyed; foreground shows rust/waterline on the post (view west)

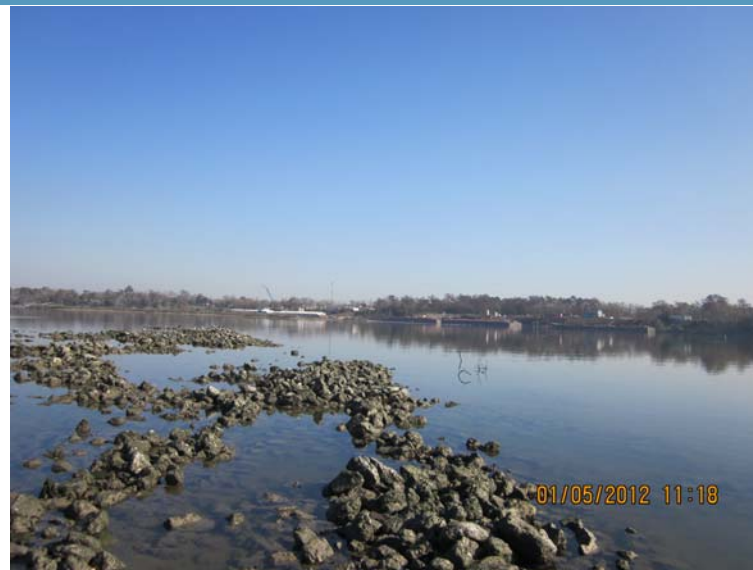
Photo: 14 View of thickened edge of Eastern Cell; photo shows intact armored cap for areas unable to be surveyed; barges on the eastern bank of the San Jacinto River in the background (view northeast)

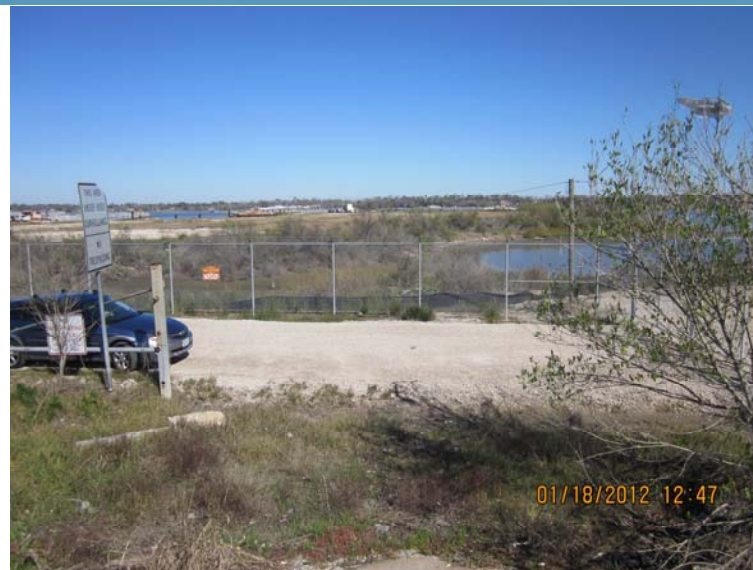
“Danger” and “No Trespassing” signs are posted at regular intervals (see photographs 50-52 for examples) on the perimeter (Photograph 47) fencing surrounding the Site. An inspection on January 18, 2012, verified that these signs are still in place (Appendix A photographs 18, 19, and 23). In addition, a total of fifteen “Danger” and “No Trespassing” signs were installed at the Site around the perimeter of the Western Cell; the signs are mounted on steel posts and set in concrete pads (see photographs 50-52 for examples). Some of these signs rotated in the wind; they were re-aligned to the intended viewing perspective. The U-brackets fastening each of the signs to the posts were tightened to provide additional resistance to the wind. Table 1 summarizes the condition of the Western Cell perimeter signs. The sign conditions documented during the inspection event are provided in Appendix A.

Photo: 18 Northern perimeter fence along the access road to the Northern Impoundments (view north)

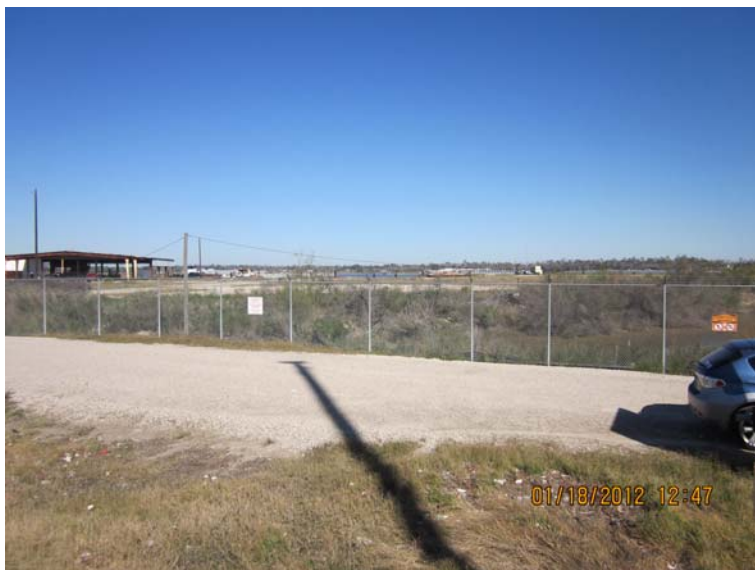
Photo: 19 Northern perimeter fence along the access road to the Northern Impoundments (view north)

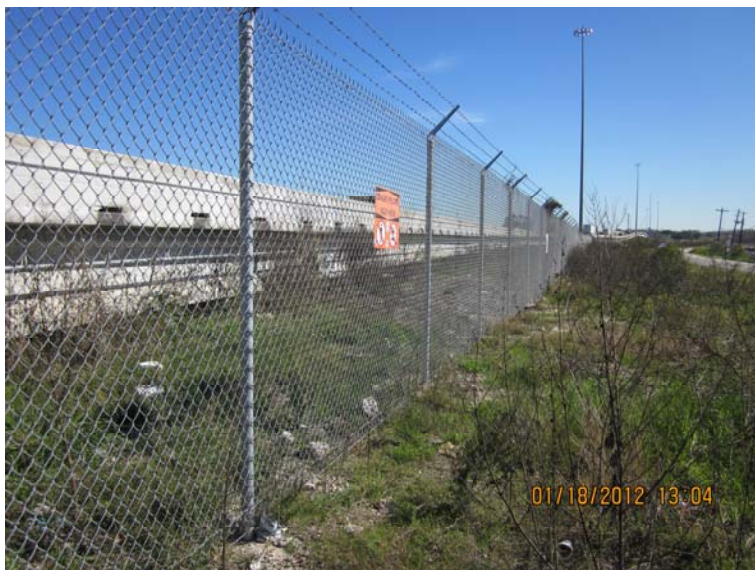
Photo: 23 South perimeter fence along the I-10 Bridge west bank access road to the southern peninsula area (south of Bridge; view southeast)

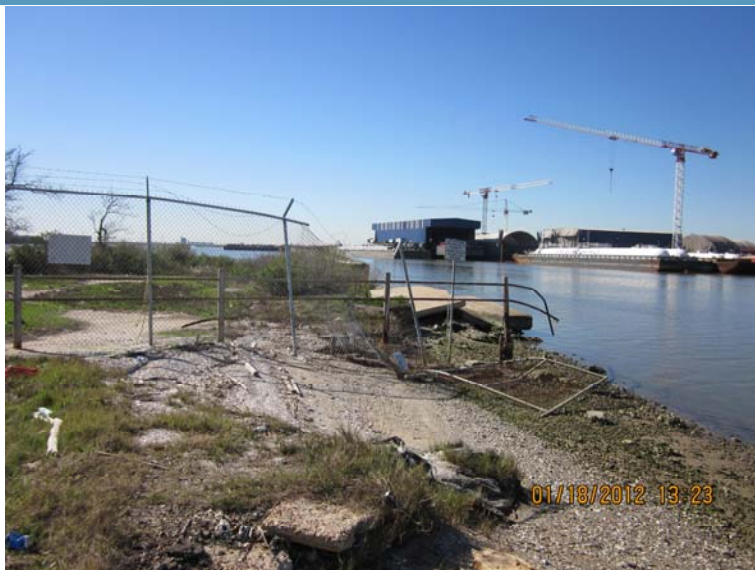
The condition of the fence terminus on the east bank of the River south of the U.S. Interstate Highway 10 Bridge has not changed since the final walk through in September 2011 conducted with the USEPA (Photograph 33). The fence in this area was damaged during TCRA implementation and as a result of a barge operating in the nearshore area. Previous documentation of the damage can be found in one of the TCRA Daily Construction Reports (Report No. 079 – Tuesday, April 12, 2011; Photograph 4). Due to the potential hazard to navigation and the downstream property owner, Coastal Water Authority, securing their property boundary along the Lynchburg Ferry Road with a chain link fence constructed in late 2011, this fence section is redundant and will not be reconstructed or discussed in subsequent inspection reports.

Photo 33: Fence terminus at the eastern bank of the River south of I-10 (view southwest)

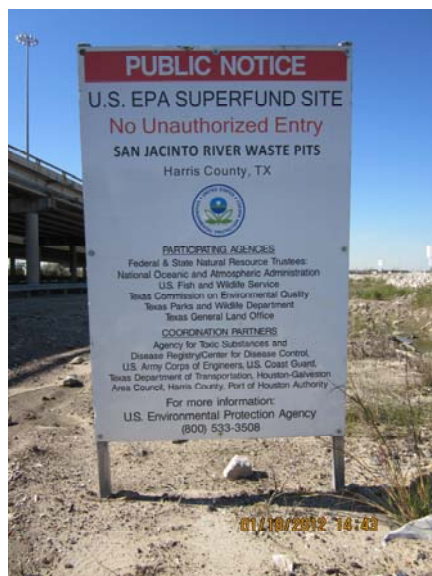
Three USEPA Public Notice signs are present around the Site (Photograph 47), 1) located near the gate entry point for the perimeter fence north of I-10; 2) near a gate entry point south of I-10; and 3) at the end of the TxDOT right-of-way north of I-10 near the San Jacinto River. These three signs were observed to be in place and undamaged.

Photo: 47 USEPA Superfund Public Notice Sign at the Northern Impoundments
